Annual Digest of Reports and Insight Articles 2020

The *CHIRP* Charitable Trust, One Kingdom Street,
Paddington Central, London, W2 6BD, United Kingdom

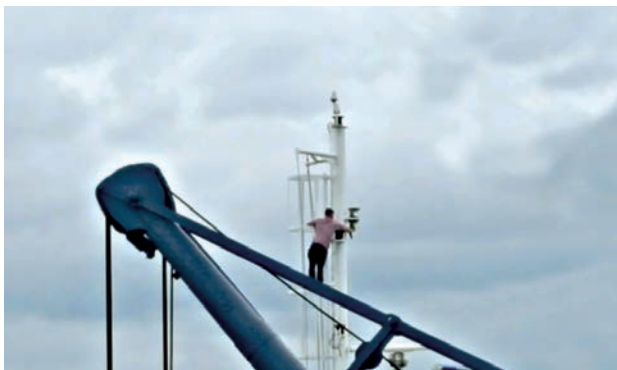
Working aloft with no safety harness or PPE

After identifying the ISM managers, CHIRP emailed the DPA who engaged immediately, allowing CHIRP to pass over details of the report. The following day the DPA contacted CHIRP with the information that the photographs in the report did indeed show a member of the ship's crew. The DPA said this was very disappointing as the actions shown were completely contrary to the vessel's SMS. Furthermore, earlier in the month the DPA had sent out a fleet-wide safety bulletin emphasising the need to complete risk assessments and permits to work for all hazardous activities.

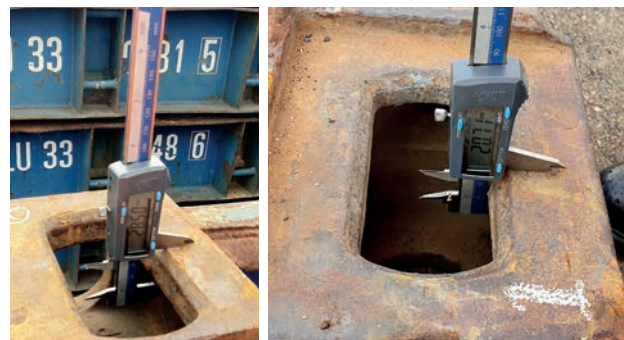
Inspection of the flat involved showed that the top plate thickness of the lifting socket of this type of unit is (at approximately 20mm) some 8mm thinner than the standard fittings on other more modern flats and the industry standard (approx. 28mm). Given that the top of the plate is chamfered, only a parallel plate thickness of 8-10mm is available for the tab to connect with. This increases the risk of the tab on the lug moving enough to enable the lug to twist and disconnect especially if there was a twist in the strop. The light rain at the time may also have lubricated the surfaces.

At ≈20mm the top plate thickness was 8mm thinner than more modern ‘flats’ and the current industry standard, ≈28mm

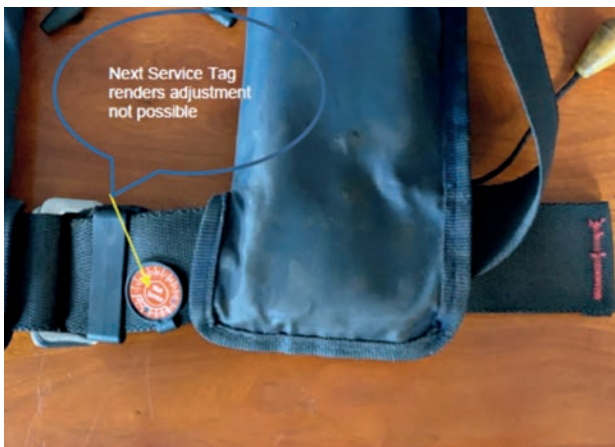
Highlighting that the positioning of the service tag renders waist strap adjustment impossible

CHIRP engaged with the reporter to confirm that the 'next service' tags in question had been fitted by a third-party service centre – they had been. After checking other vessels in the company, the reporter advised CHIRP that four other ships had equipment serviced by the same service provider. However, it appeared that this was an isolated incident which had not been replicated elsewhere. The DPA forwarded full details to the servicing company who gave assurances that it would not happen again.

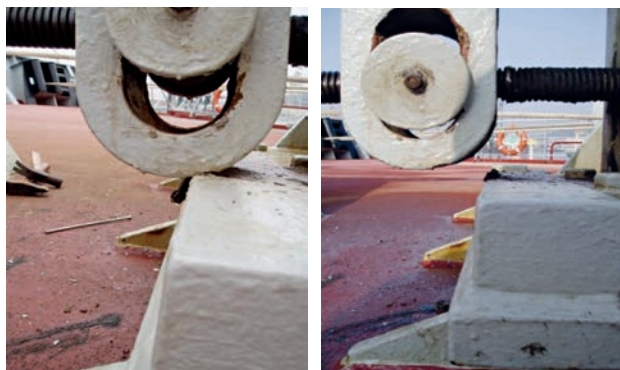
The reason for the freedom of movement was that the crosshead, located between the brake application shaft and the brake tensioning plates, was in contact with the windlass foundation, as shown in the photograph below:

Incorrect Brake Adjustment Correct Brake Adjustment

The bottle screw was then tightened to the correct setting, i.e. allowing the gypsy to rotate freely in the brake ‘off’ position, but in the brake ‘fully on’ position the hydraulic motor could not rotate the gypsy. The clearance between the crosshead plates and the foundation with the brake fully applied was in the region of some 30 – 35mm.

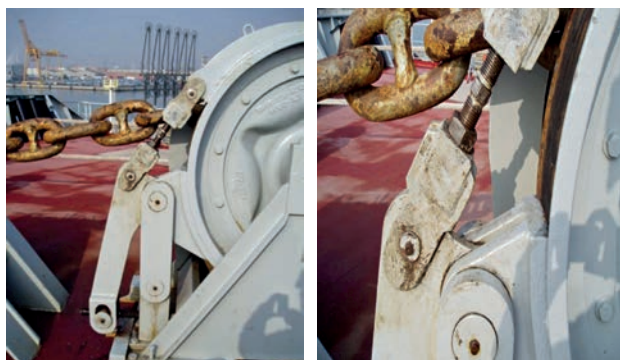
Brake ‘Fully On’ Bottle Screw Adjustment

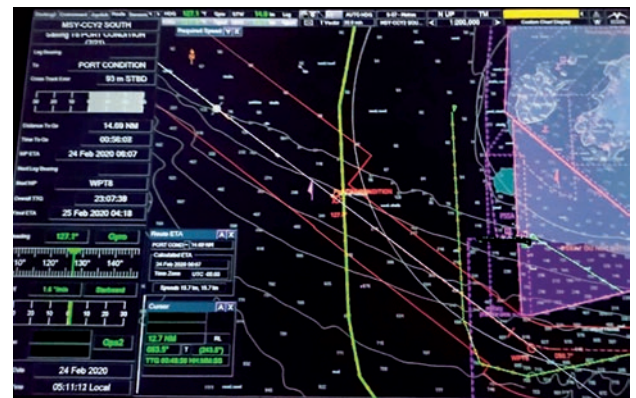
Screen shot of the Radar/AIS showing the reported ship transiting within the adjacent PSSA.

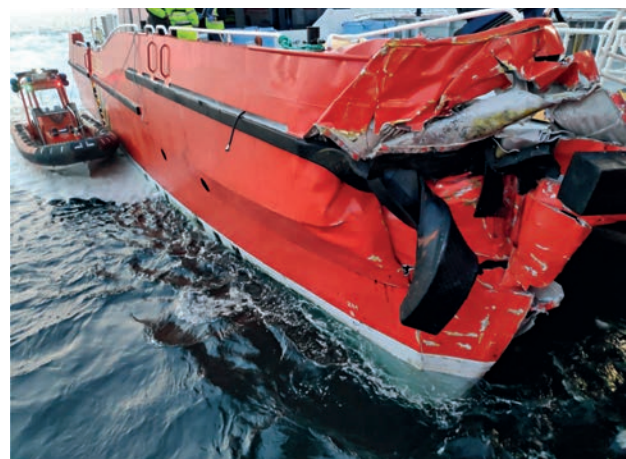
The Consequence of distraction.

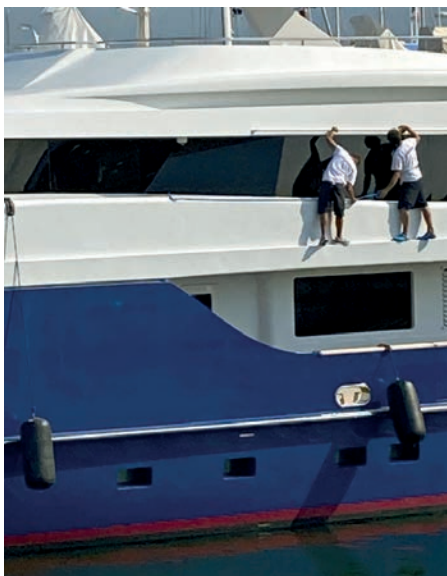
Figure 3 – Another example of poor safety culture in the superyacht sector.

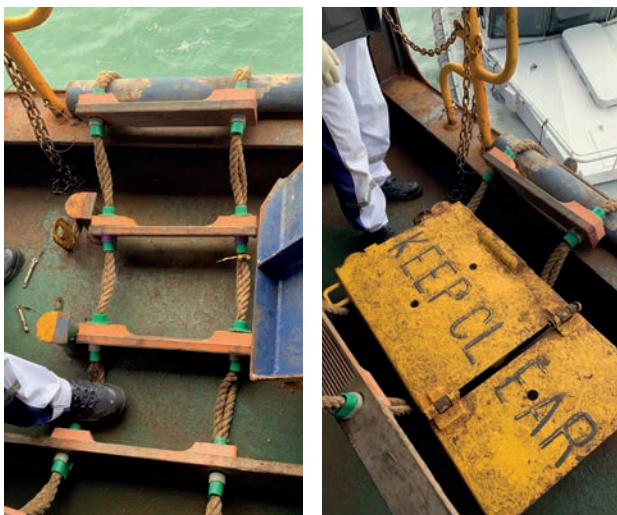
They say a picture paints a thousand words – this clearly demonstrates the appalling lengths that some mariners will go to with respect to endangering life.

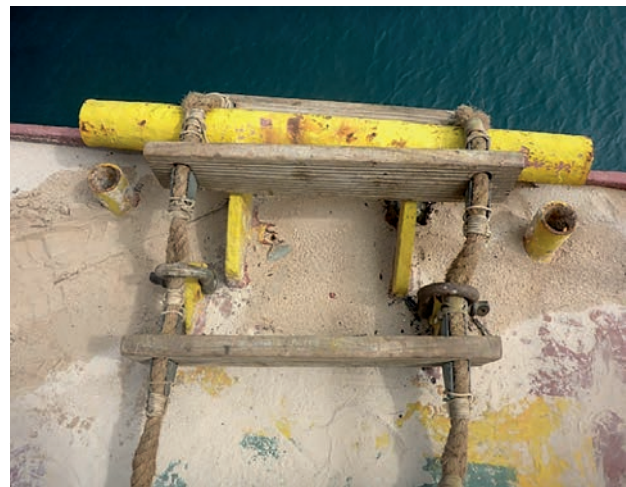
Pilot ladder incorrectly secured to the deck using D-shackles to choke the side ropes.

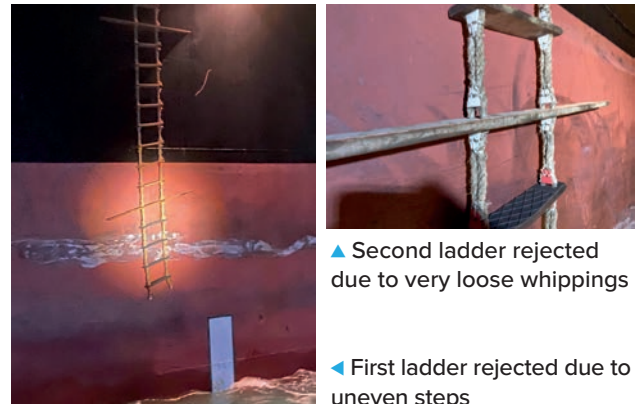
▲ Second ladder rejected due to very loose whippings

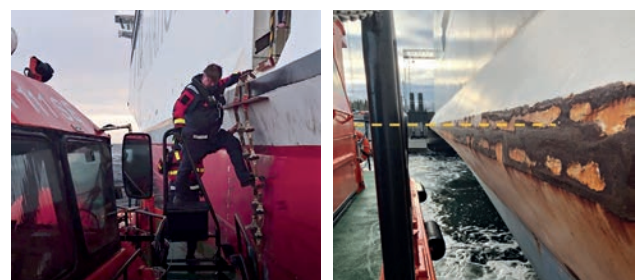
Examples of ship side features that render the vessels non-compliant by design

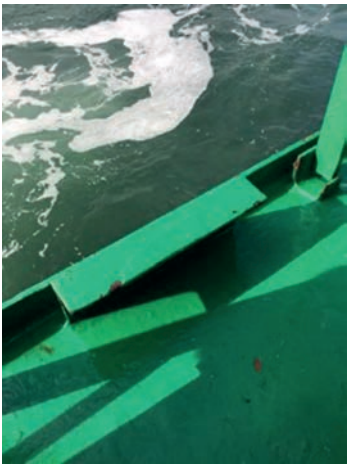
Notorious offender...

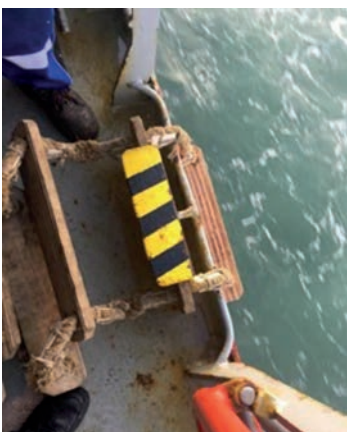
Deck tongue supporting the ladder.

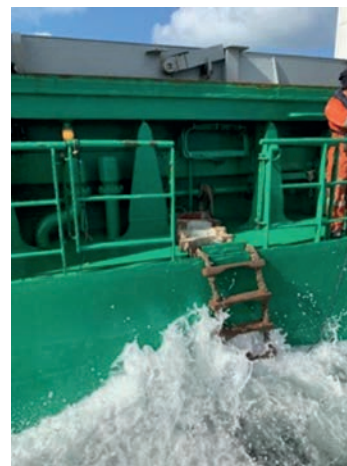
Notorious offender, and it's not even a pilot ladder. As we say: non-compliant as hell.

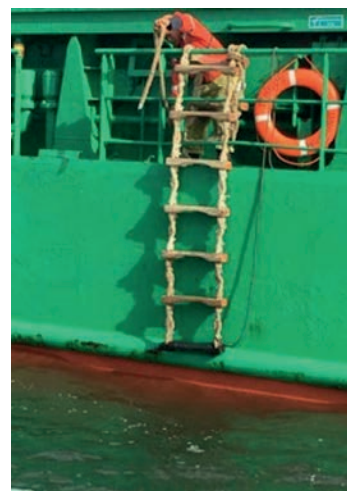
Notorious offender with bulwark setup. It's not even a pilot ladder (at least 6 non compliances).

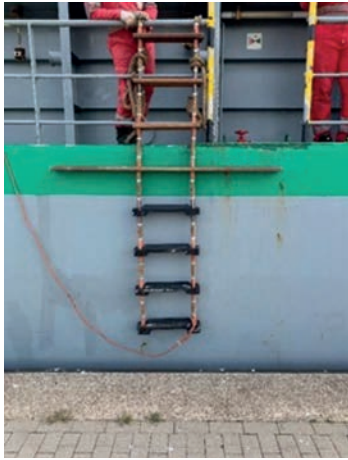
This setup means you have to stumble sideways to reach the entrance.

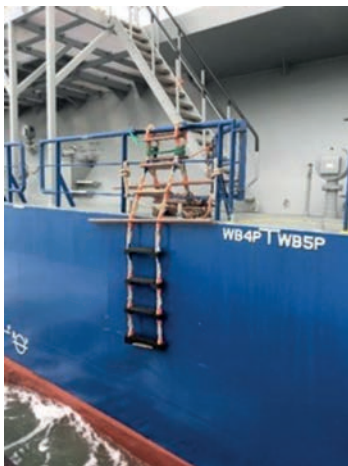
Sideway shuffle again – how strong is the railing?

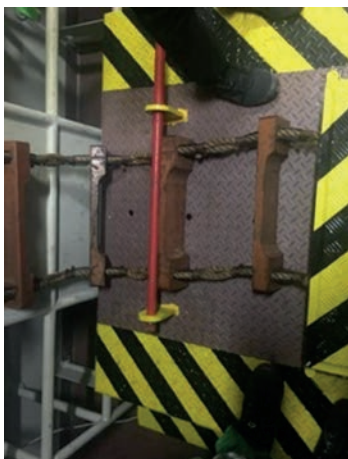
Always a surprise when you lift the lid.

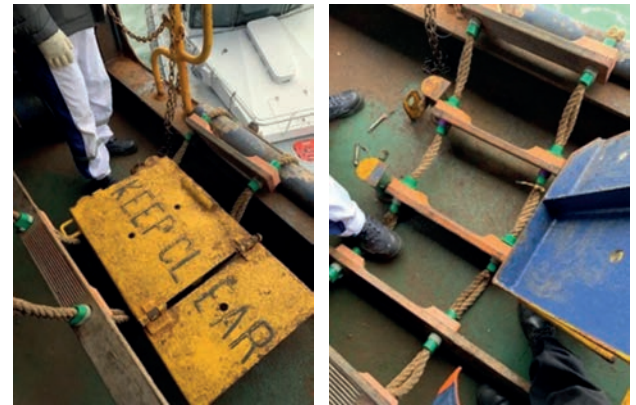
Looks like a safe access but the 3cm piece of steel is the only thing between life or death.

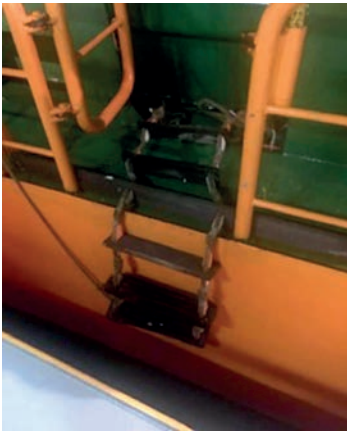
Another spreader used as a securing method.
