Annual Digest of Reports and Insight Articles 2020

The *CHIRP* Charitable Trust, One Kingdom Street,
Paddington Central, London, W2 6BD, United Kingdom

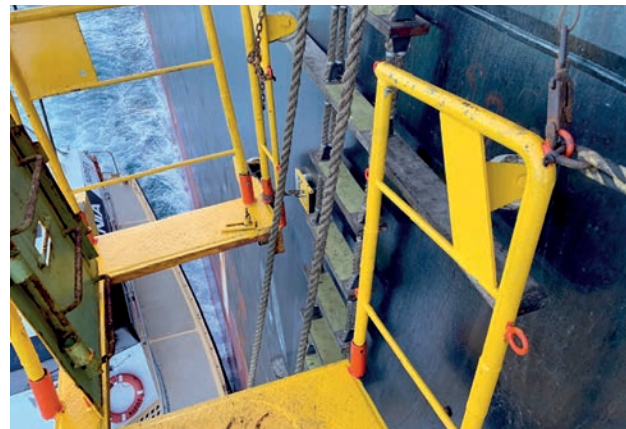
Example of a compliant combination PBA with trap door.

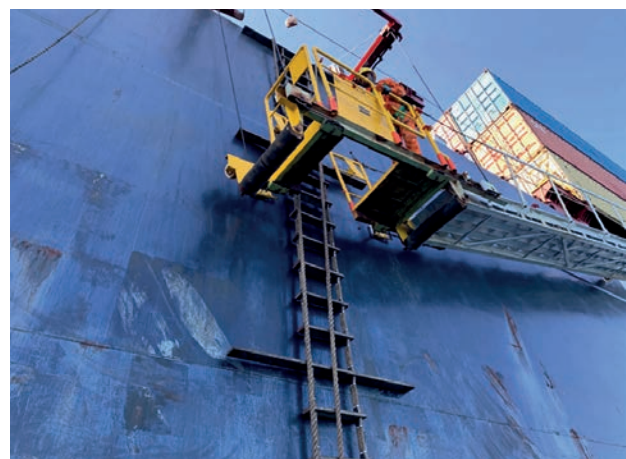
Compliant combination PBA with trap door – pilot ladder and man ropes extend up to and are made fast on vessel's deck

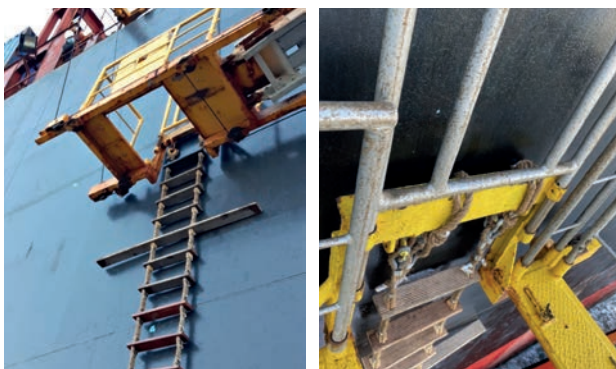
2 examples of non-compliant ‘trapdoor’ pilot boarding arrangements

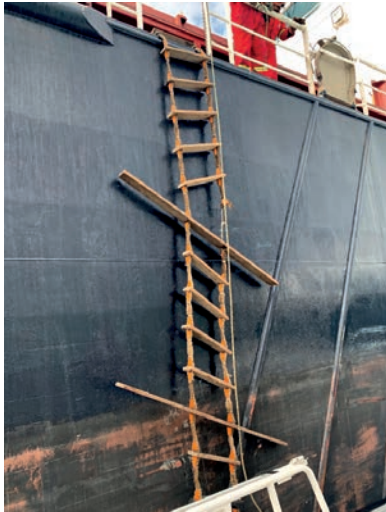
Parted ladder

While boarding the vessel at the pilot exchange station, one of the side ropes snapped. No other pilot ladders were available.

In addition, the information about the incident was made available to all company vessels and crew. The company was not satisfied with using manila ropes in pilot ladders due to the quality of rope available and weaknesses being difficult to spot. They had started a replacement programme using better quality rope.

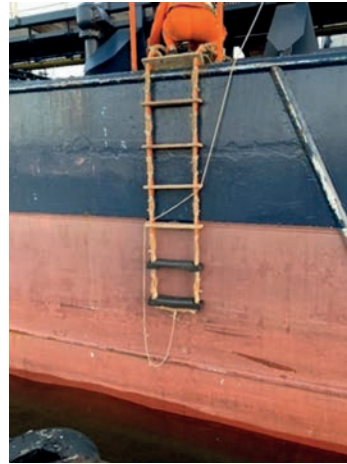
2 metres of ladder with at least 4 non-compliances.

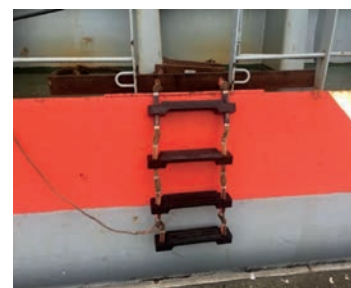
A spreader used for securing the ladder behind a very thin piece of railing.

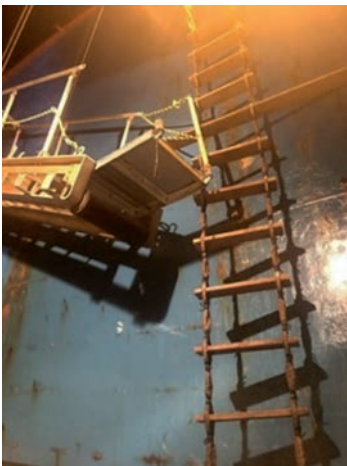
A non-compliant combination arrangement.

SOLAS V.23 clearly states (3.3.1): a pilot ladder requiring a climb of not less than 1.5m and not more than 9m above the surface of the water etc. etc.

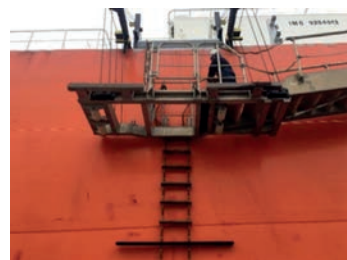
Non-compliant trapdoor arrangement.

Another name often used for this platform is "trapdoor system". Another wonderful invention to rig a ladder, at least a number of people must have thought it would be a great system. The problem is however that it introduces more risk and more non-compliances. (Keep It Simple Stupid!).

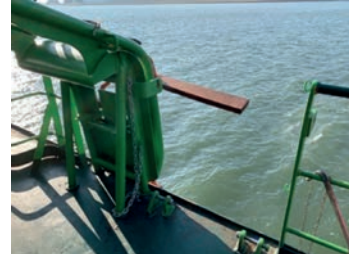
Non-compliant (by design) pilot ladder winch reel, spreader obstructing entrance after the sideways dive.

In this final picture in this section we can clearly see the spreader is obstructing your safe access to the ship, and again you have to stumble sideways. Conclusion in this section: Read the manual or look at the poster.

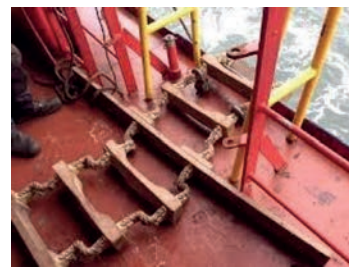
Check the condition of the sideropes.

On the photo we see that the shackles have been used often to keep the ladder in place. The photo shows really well what effect the steel shackles have on the manilla ropes - twisted and beaten up. Just wonder if this ladder will pass the 30-month compulsory strength test (ISO799-1/2019 10.4, for ISO certified vessels).

Shackles are an easy way for the crew to keep a ladder in place, but is it actually securing the sideropes??? No, it’s not - when weight is put on the ladder, the ladder will move freely under the shackles until the next chocks and step has reached the shackles.

Basically, the ladder will be held in place solely by step and chocks. Let’s think back a moment, we have seen that each siderope can handle 2400 kilos and that a step can handle 880 kilos. If or when the pilot launch hits the ladder, it will be ripped to pieces. 880 kilos instead of 4,800 kilos.

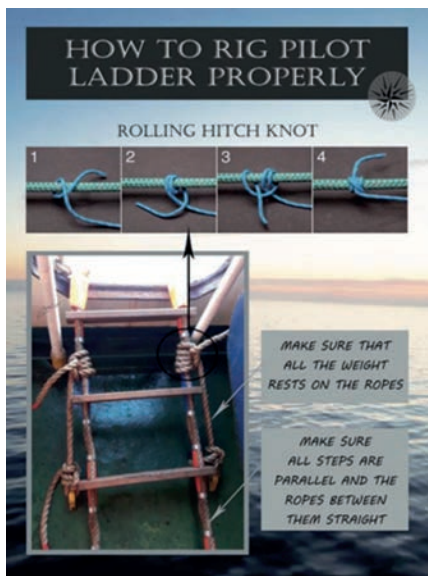
How to secure the pilot ladder correctly at deck level.

This is it... nothing to it, simple and safe!

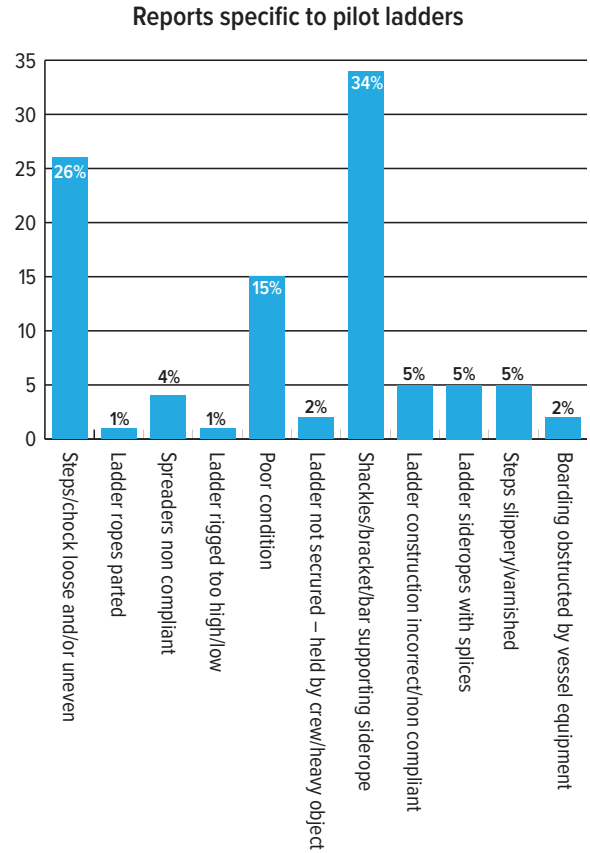
Figure 3 – Reports specific to pilot ladders.

The chart in Figure 3 shows deficiencies of pilot ladders, where a single ladder was utilised for pilot embarkation or disembarkation. CHIRP received 66 reports in this category, which detailed 99 specific deficiencies.

It is a damning indictment that 42% of the reports received highlight uneven steps, loose chocks, a ladder in poor condition or, in one case, the side ropes parting completely when weight was placed upon them prior to disembarkation. This highlights a deficient safety culture and woefully poor quality of seamanship as well as indicating a complete disregard for the safety of the pilot who has to use the ladder. It should be noted that a small percentage of the uneven steps/chocks were in fact ladders that were relatively new and manufactured ashore. CHIRP is aware that in some cases this has been followed up by the port or national administration who have contacted the manufacturer(s) in question. The same applies to some of the pilot ladders which have been manufactured ashore and have arrived varnished.

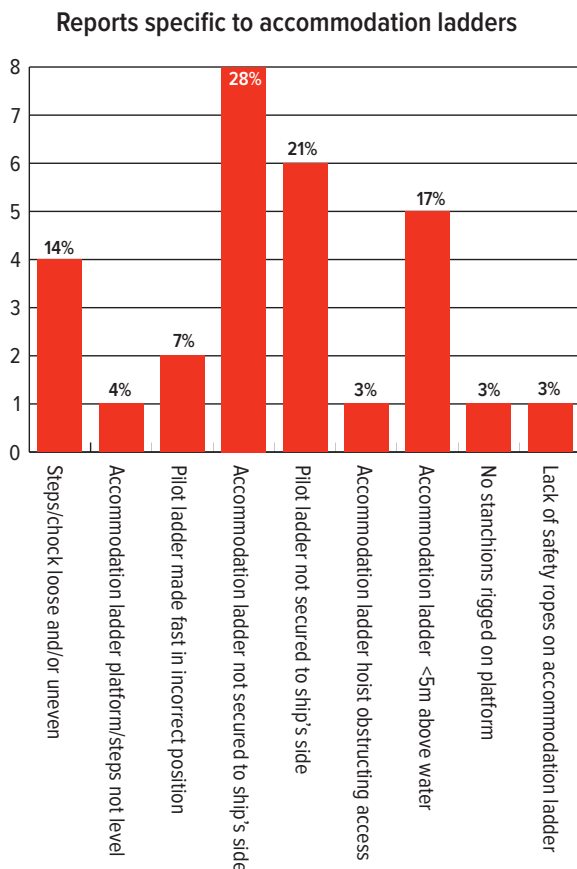
Figure 4 – Reports specific to accommodation ladders.

Figure 4 shows deficiencies related to accommodation ladders with 17 reports received and 29 separate deficiencies highlighted. Almost fifty percent of the reports relate to either the accommodation ladder itself and/or the pilot ladder, not being secured to the ships side as required by the 2012 SOLAS V regulations. Another significant slice of the pie describes the accommodation ladder itself being less than five metres above the waterline. Anything other than a light swell could cause damage to either the attending pilot vessel and/or the accommodation ladder itself.

The smaller sections of the diagram deserve a mention since they are extremely dangerous – accommodation ladder steps not being level, a lack of safety ropes on the accommodation ladder and no stanchions rigged at the bottom of the ladder at the pilot access are all extremely dangerous. CHIRP Maritime would argue that there is no excuse for this – in dialogue with the reporters, we discovered the vessels concerned had confirmed that the arrangements were ready in all respects to effect a safe pilot transfer. Clearly this is not the case, and in no situation was the vessel being rushed to prepare the arrangement. This is safety culture and supervision in its poorest form.

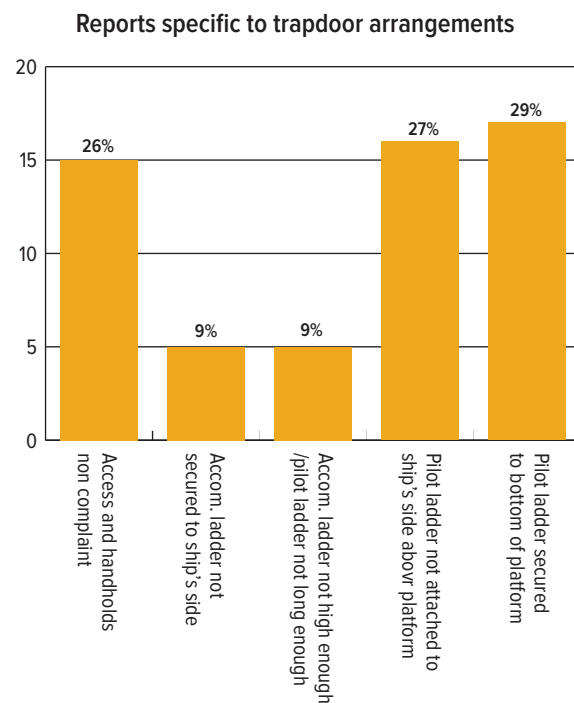
Figure 5 – Reports specific to “trap door” type combination rigs.

Figure 5 shows deficiencies with respect to “trap door” type combination rigs. CHIRP received 25 reports related to these arrangements and the analysis shows a high number of deficiencies, namely 58. The reason for this is not at all surprising. It is almost universally impossible to rig a trapdoor arrangement that is one hundred percent compliant with the 2012 SOLAS V regulations.

The largest areas of failing are the pilot ladder being secured to the bottom of the accommodation ladder, the pilot ladder (often another ladder) not being attached to the ships side 1.5m above the accommodation ladder platform, and access and handholds being non-compliant – this is causing repeated difficulties for the pilots to make the transition from pilot ladder to accommodation ladder.

CHIRP queries all of the above but specifically the pilot ladder being secured to the bottom of the accommodation ladder. Photographic evidence often shows modifications having been made to accommodation ladders, and that lugs have been welded to the base of the ladder to allow a pilot ladder to be shackled on. Despite the fact that this is non-compliant with the regulations, CHIRP asks the question, “Who authorised these arrangements?”

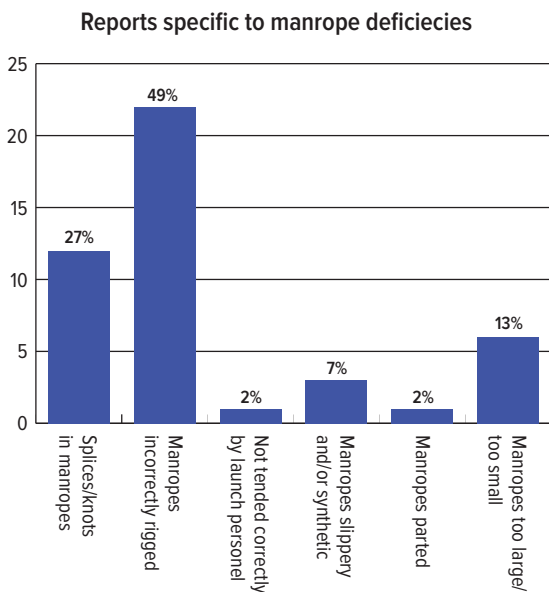
Figure 6 – Reports specific to manropes deficiencies.

CHIRP received 37 reports where manropes were specifically mentioned, and 45 deficiencies were highlighted. Almost half of the deficiencies related to the incorrect rigging of the manropes. Notwithstanding the nature of the other deficiencies reported, all of the failings came down to a basic lack of seamanship, supervision, safety culture and training. This is one area where any change to pilot ladder regulation is unnecessary – all of the deficiencies can be addressed on board to ensure that manropes are rigged correctly.

The whole chart demonstrates a lack of understanding as to what the manropes are used for, and this requires the urgent attention of vessels crews and their managers ashore in order to rectify the problem.

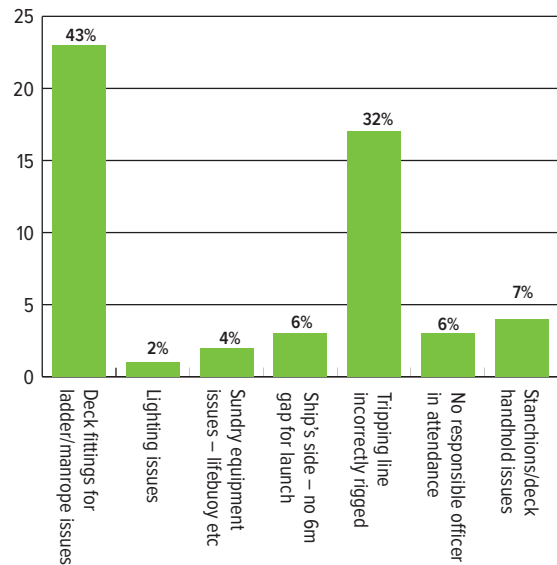
Figure 7 – Sundry equipment deficiencies.

The largest area of failing were the deck fittings (or more correctly lack of) for side ropes and manropes. The deficiencies were noted for both pre 2012 and current SOLAS vessels. As noted earlier, all vessels have had ample time since the introduction of the current regulations to rectify any failings, so the question has to be asked why they have not done so? There is much more to be done by flag administrations, their recognised inspection organisations, port state control, and shipping companies in order to rectify this area.

Incorrect retrieval lines – often called tripping lines – accounted for almost one third of the reports, where the line was rigged in such a manner that it could become fouled upon the attending pilot launch or obstruct the safe access to the ladder for the pilot. The majority of failings were that the line led aft and not forward – also the line was rigged below the bottom spreader. All totally avoidable with a little care and attention.
